Manhole Inspection Summary

Manhole # S35U__061MH

Location Address: **1439 harden court**

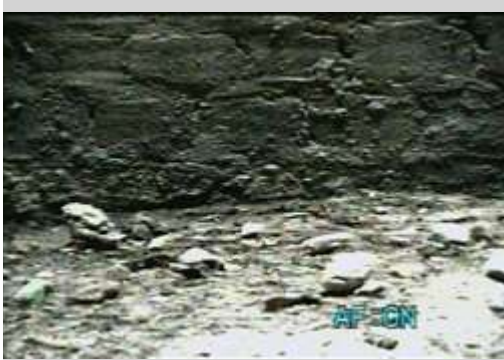
Miscellaneous

bench debris

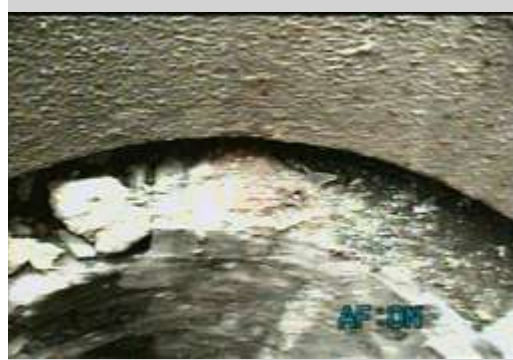
Defect 1

Condition: ☐ Sound ☐ Cracked ☐ Root Intrusion ☒ **Loose Brick** ☐ Deteriorated

loose bricks, offset

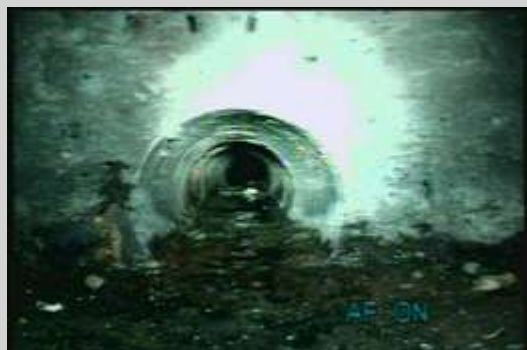
12 O'Clock Outflow

Deposits: ☐ None ☐ Mud ☒ **Sludge** ☐ Debris ☐ Grease

Silt Depth: **2** (in.) Deposits Extent: **Medium**
